WATER DAMAGE ASSESSMENT

**Dartmouth Town Hall
400 Slocum Road
Dartmouth, Massachusetts**

Prepared by:
Massachusetts Department of Public Health
Bureau of Environmental Health
Indoor Air Quality Program
December 2019

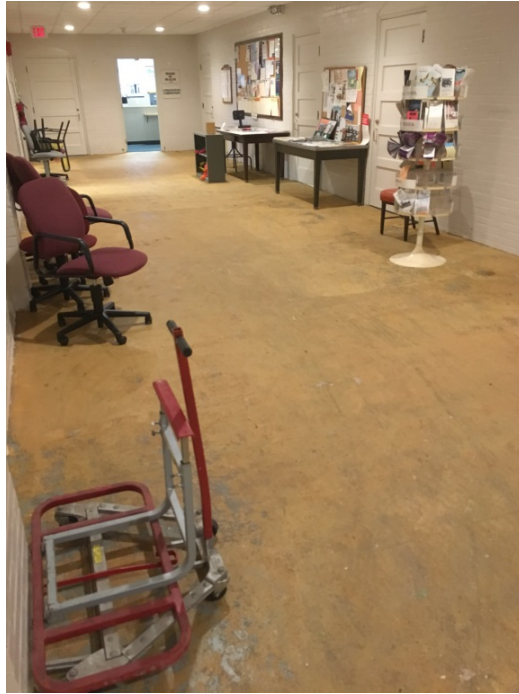
Picture 1

The DTH experienced a water backup which wet extensive areas of the basement hallways and some adjacent rooms. At the time of this visit, carpet had been removed from the hallway (Picture 1). BEH/IAQ staff were asked to examine the DTH regarding health concerns related to water damage and installation of wall-to-wall carpeting on the basement floor.

Bare floor of DTH basement hallway

1. Implement any remaining recommendations made in the previous IAQ assessment, which can be downloaded at <https://www.mass.gov/info-details/indoor-air-quality-reports-cities-and-towns-d>.
2. Consider removing any remaining carpeting in the basement that has been wet and not properly dried.
3. Replace basement flooring with materials that will either not be a mold growth medium (e.g., floor tile) or a covering that can serve as insulation and a vapor barrier (e.g., various types of carpet tile).
4. Refer to resource manual and other related IAQ documents located on the MDPH's website for further building-wide evaluations and advice on maintaining public buildings. These documents are available at: <http://mass.gov/dph/iaq>.
